# Percolation Testing

New Build Semi-Detached Dwellings

Development Site Between  
58 and 62 Drift Avenue  
Stamford  
Lincs. PE9 1UY.

September 2016

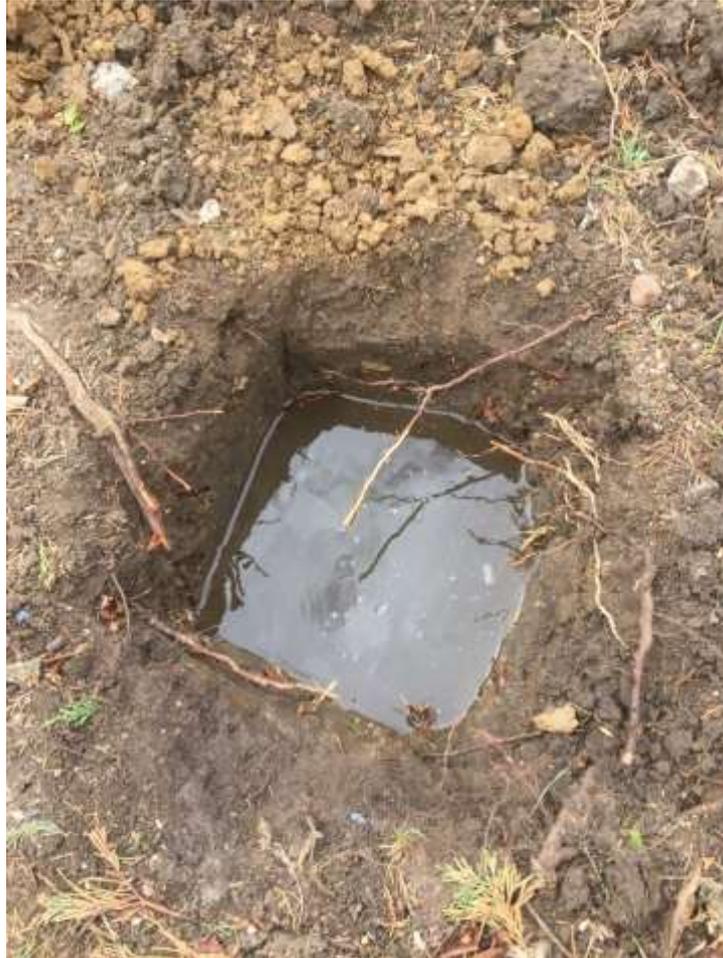
Figure 1 indicates the trial hole dug on the 7<sup>th</sup> September 2016 and filled with water prior to the test being undertaken.

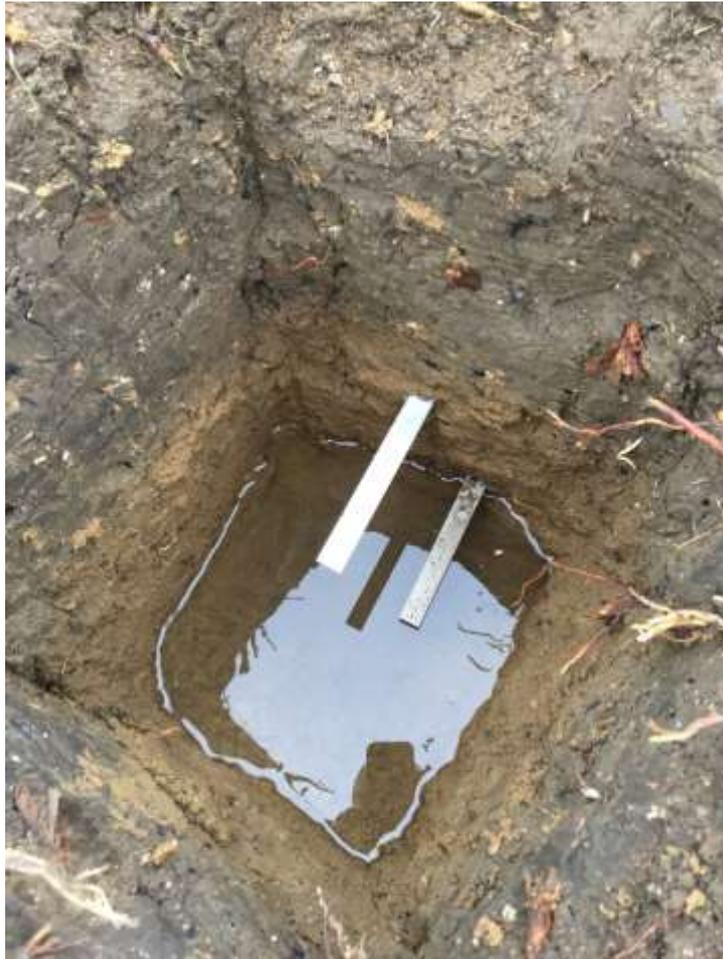
Figure 2 is a close up of the trial hole showing where steel markers have been positioned at the 75% and 25% positions respectively.

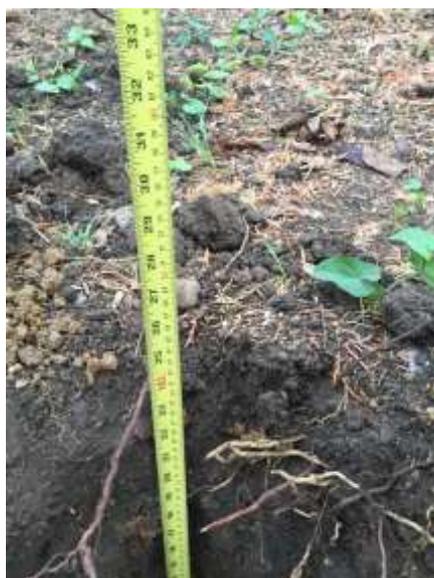
Figure 3 confirms the trial hole has been dug to the depth required on drawing DA-02 rev P01/

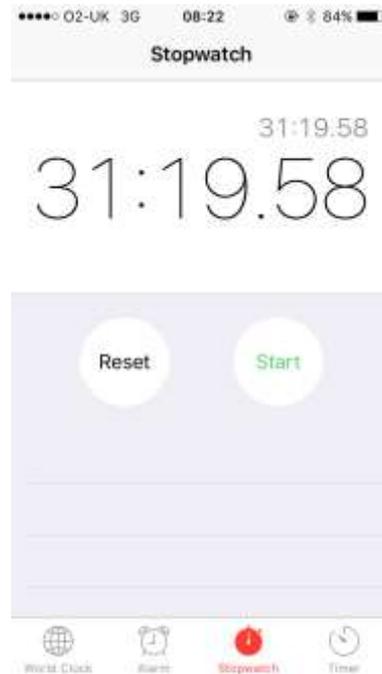
Figure 4 confirms the time it took the water level to fall from the top nail to the bottom nail was 31 minutes and 19 seconds.

This figure is then converted into seconds, which totals 1879 seconds.

1879 seconds is then divided by 150mm, which gives a Vp of 12.53.

This figure **only just falls** within the range of 12-100 Vp.
